Manhole Inspection Summary

Manhole # S09II1012MH

Insp Date: **1/12/09 2:40 PM**

Location Address: **3605 WOODLAND AVE**

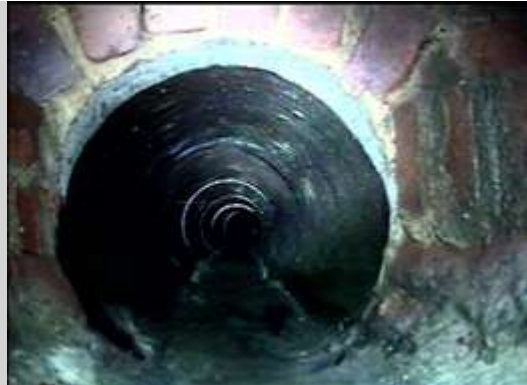
12 O'Clock Outflow

12 in. Circular Gravity Sewer
Pipe Out @ 12 O'Clock

Pipe Height: **12** (in.) Rod and Bar (Angled)
Pipe Material: **Clay** ☐ Pipe Lined
Invert Depth: **9.97** (ft.) Flow Characteristics: **Slow**
Deposits: ☒ None ☐ Mud ☐ Sludge ☐ Debris ☐ Grease
Silt Depth: (in.) Deposits Extent:
Infiltration: **None** Pipe Seal Cond: **Sound**

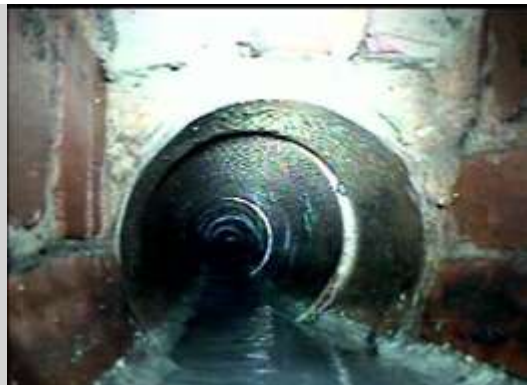
3 O'Clock Inflow

8 in. Circular Gravity Sewer
Pipe In @ 3 O'Clock

Pipe Height: **8.4** (in.) Rod and Bar (Angled)
Pipe Material: **Clay** ☐ Pipe Lined
Invert Depth: **9.80** (ft.) Flow Characteristics: **Slow**
Deposits: ☒ None ☐ Mud ☐ Sludge ☐ Debris ☐ Grease
Silt Depth: (in.) Deposits Extent:
Infiltration: **None** Pipe Seal Cond: **Sound**
